CASE STUDY ON LANDSLIDE INVESTIGATIONS IN HIMALAYAS

Paper No.2.38

INVESTIGATIONS AT LANDOUR CANT

INVESTIGATIONS ON NH-52A

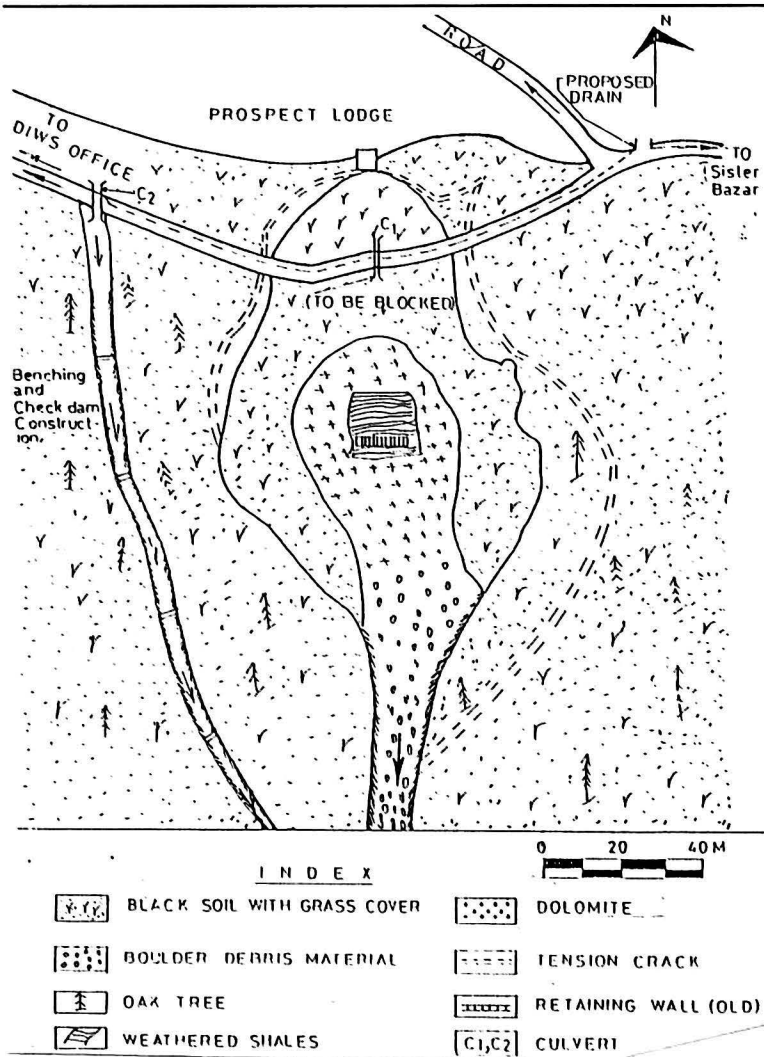
Fig. 1. Plan of sinking area affecting the road

The physical evidences show the presence of an old landslide in the area. The percolation of water and subsequent loss of strength lead to movements in the slope mass. The debris slope material, discharge of water into the slide area through culvert located at the crown of slide are some of the main causes of slide.

To improve the stability of hill slope there was a need to prevent percolation of water into the slope, deterioration of exposed dolomite, dolomitic limestone, clayshales and weathered shales, and to stabilise loose debris material. Suitable steps to reduce surface erosion problem and to improve drainage system to mitigate the effects of extensive flow of rain water were recommended. The same proposals were implemented in the field.

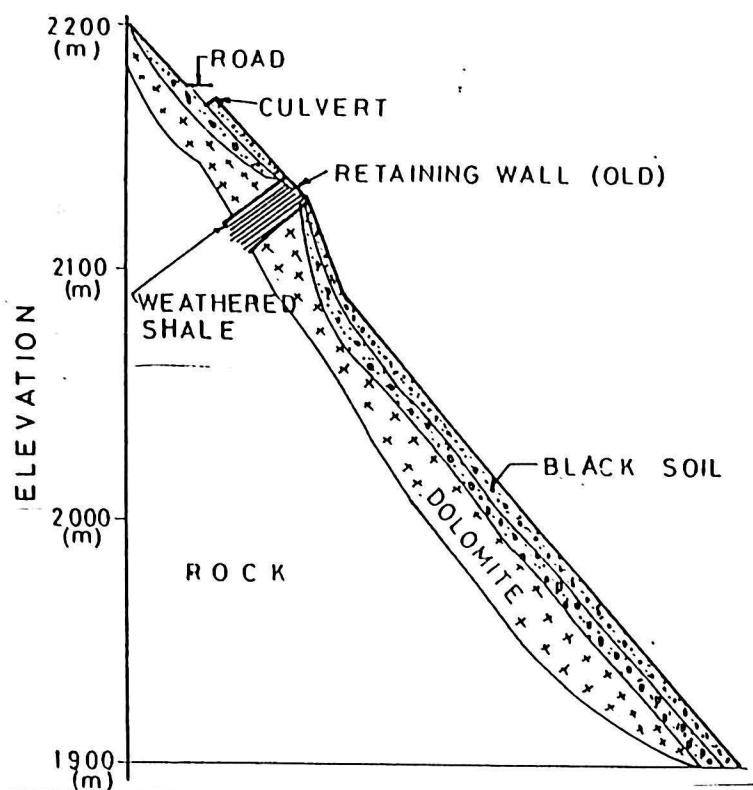
Analysis using the strength parameters determined in the laboratory i.e. $C=10$ kPa and $\Phi=40$ degree gives the factor of safety equal to 0.90, indicating the slope to be unstable even without any piezometric line. Field survey had indicated that the main body of the slide area consists of debris and exposed rocks of dolomite, dolomitic lime stone and weathered shale.

Fig. 2. Typical section of slide affected slope

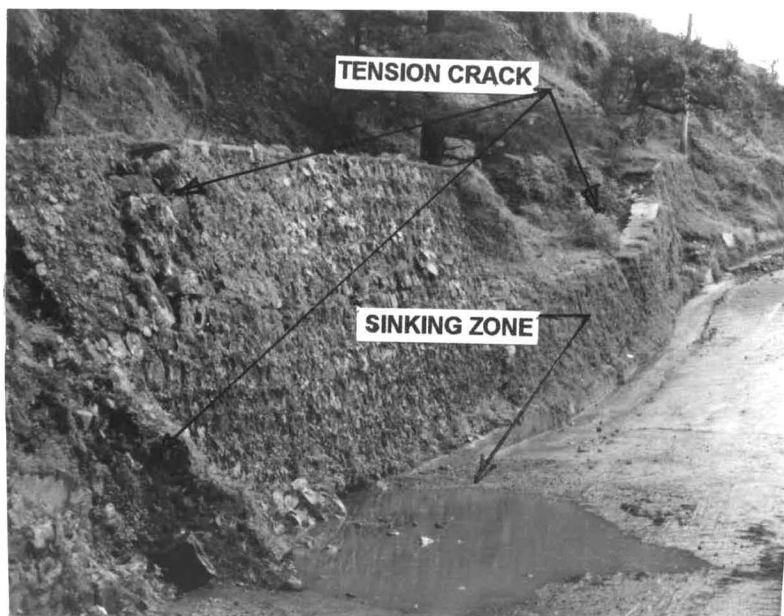
Fig. 3. Photo showing damages at road section

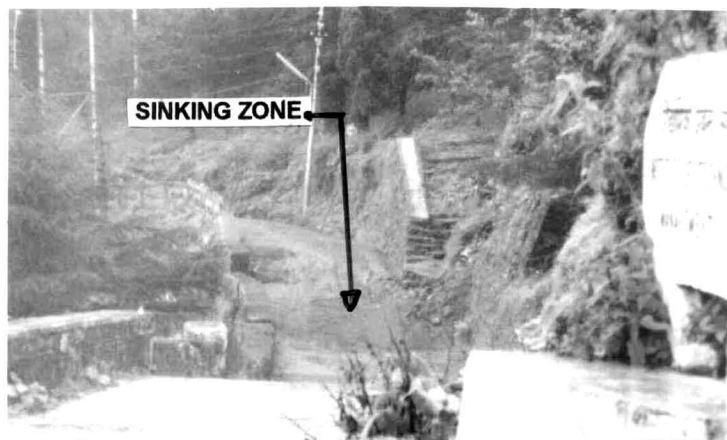
Fig.4. Photo giving general view of sinking zone

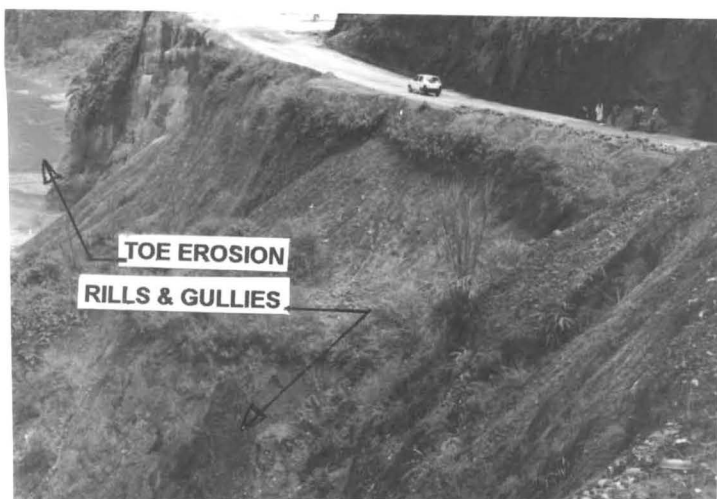
The hill slope at the location of the affected stretch comprises of the layers of siltstone and boulder beds of upper Siwalik formation. The top layer being more permeable, results in the excessive percolation of rain water into the slope. In most of the locations the subsurface water was observed to be seeping out at the interface separating the two formation layers viz. the siltstone and boulder bed. At these locations the lower formation layer is denser and has low permeability as compared to the top layer. A number of seepage points leading to gully erosion and formation of rills on the denuded downhill slope were observed. Fig.4 shows the damages to road stretch on National Highway-52A.

Fig.5 Photo showing damages to road (NH-52A)

To reduce the impact of river water at the toe and stabilise the downhill slope by constructing a toe wall all along the affected stretch in wire/synthetic crates.

To divert the flow of river away from the hill side slope, by constructing a series of spurs located at appropriate distances.

To construct rubble drains at the locations of seepage points in the downhill slope. A geotextile layer may be used around the drains which will act as a filter preventing the migration of slope material.

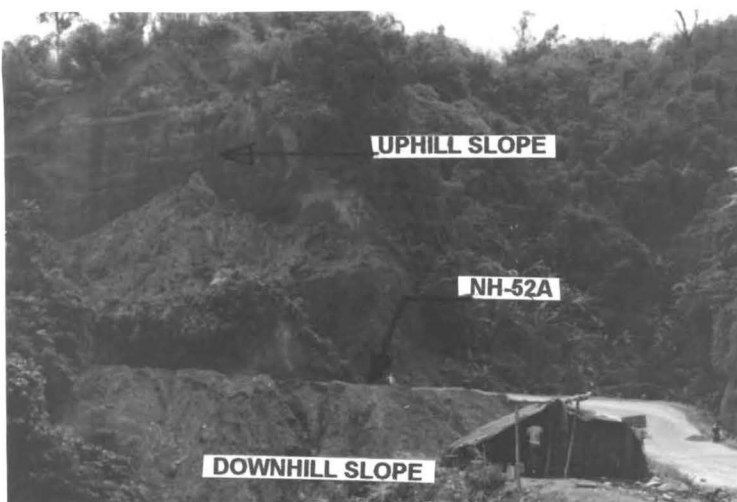
Fig.6. Photo showing landslide on uphill slope (NH-52A)

erosion due to river Dikrong and the seepage of subsurface water into the affected area. The formation on downhill slope is affected by erosion and denudation. Numerous seepage points all along the downhill slope and the culverts discharging onto the downhill slope, result in the loss of slope material and also the formation of numerous rills and gullies due to surface runoff.

The sliding process is accentuated by the rains and subsurface water which seeps out at a number of places through the contact of boulder bed (permeable strata) and underlying fine grained siltstone layer (impermeable strata). At a number of points in the affected stretch, water from underground springs and channels migrating towards the slope through gullies, still enriches the degree of saturation of slope material. During rainy season these streams not only saturate the slope material but also cause erosion.

On the basis of stability analysis it was suggested that the affected slope should be restructured to make flatter using benching technique and to restore down hill slope.
